TDS-2056-ENV

Assessment and Remediation Technologies for Environmental Cleanup

Photolytic Destruction Technology for Chlorinated and Petroleum Hydrocarbons

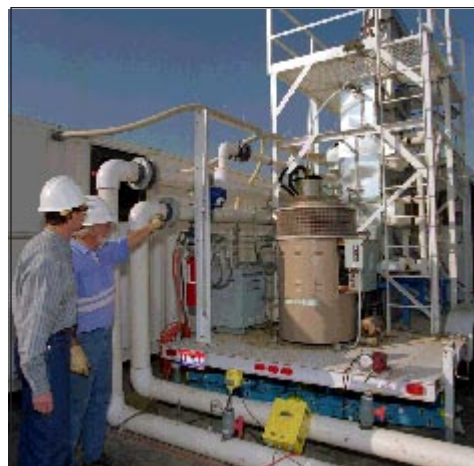
Figure 1. Photolytic destruction system adsorber tank.

Eighteen specific volatile organic compounds (VOCs) and carbon dioxide have been identified in the exhaust vapor of the existing soil vapor extraction (SVE) system. Process Technologies, Inc. (PTI) was selected by SWDIV to use "photolytic destruction (PD)" for removal of VOCs from the exhaust of the SVE system. See Figure 1.
